Subject: Sheet Pile Bulkhead Investigation—Report Submittal
M&N File No.4099

SHEET PILE BULKHEAD INVESTIGATION
Crescent City Harbor District
Crescent City, California

MOFFATT & NICHOL ENGINEERS
3000 Citrus Circle, Suite 230
Walnut Creek, California
M&N File No. 4099

Date Of Site Investigation:
11 December 1997

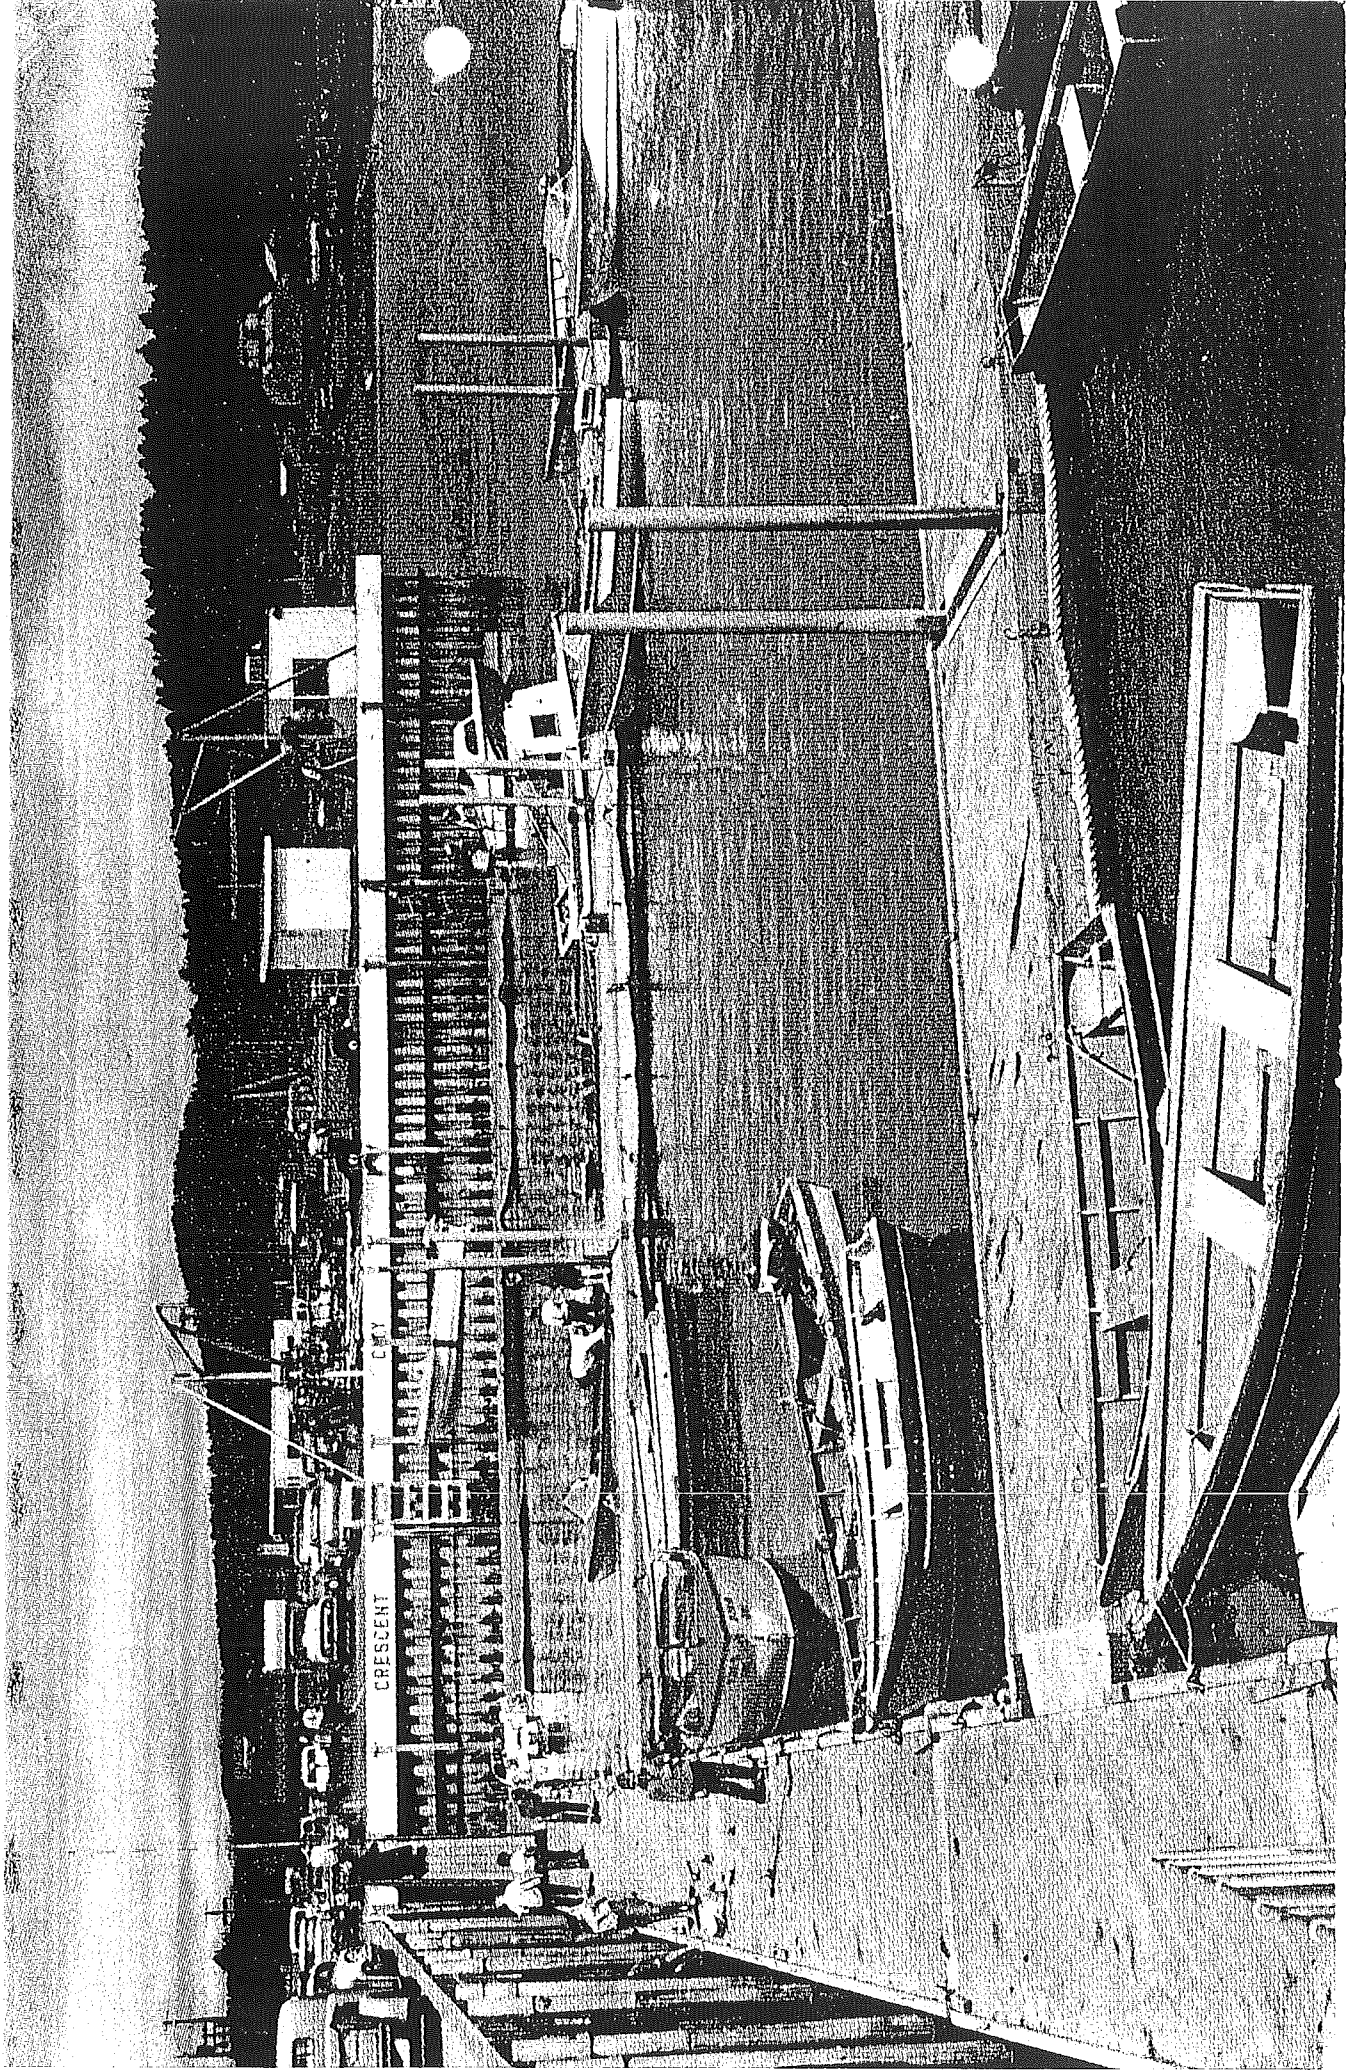
Photograph 1 -- West wall looking east, circa late 1950s

The first phase was built for a 30,000 sq. ft. parking lot, launching platform and floating docks. It was comprised of a steel sheet pile wall 100 ft. long on the west side extending south from an existing steel sheetpile bulkhead (abutment to Citizens Dock), and a steel sheet pile return wall 50 feet long on the south. There was a 150 ft. long riprap extension on the east end of the south wall. This first phase of the wall is shown in Photograph 1.

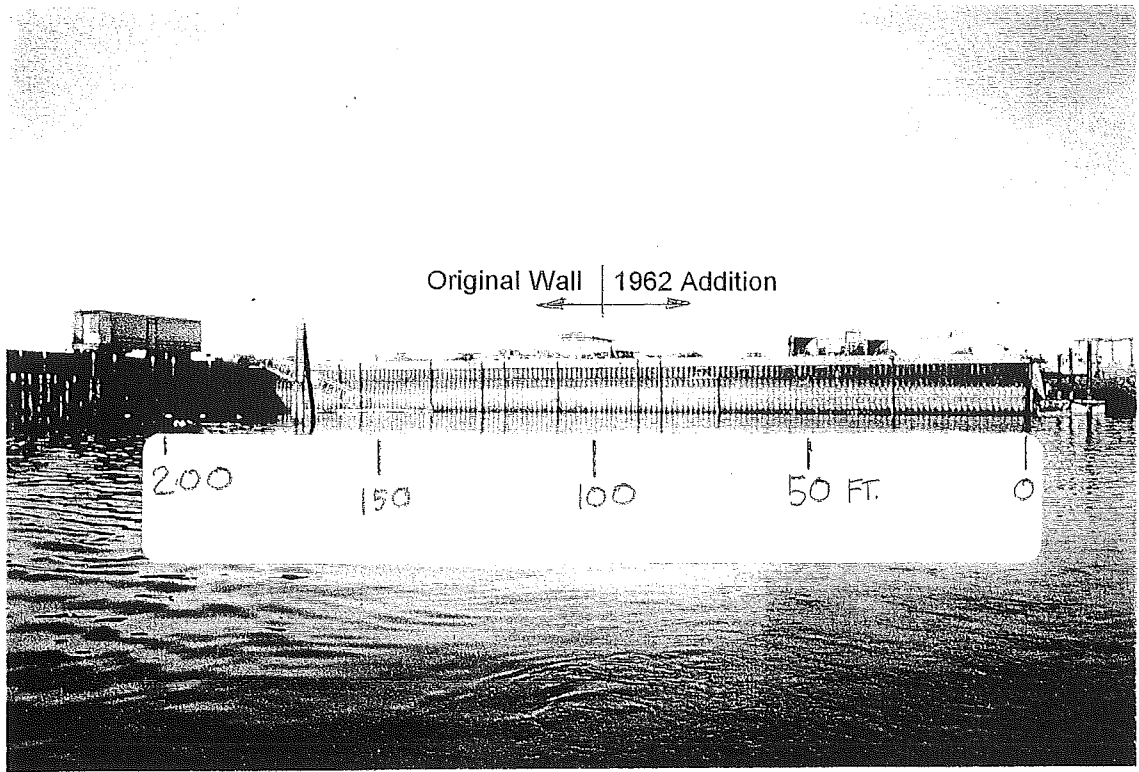
Photograph 2 -- West wall looking east

The second phase extended the west wall an additional 100 ft. to the south, doubling the available parking area. A new 100 ft. long steel sheet pile wall was built on the south side with a 100 ft. long rip rap extension at the eastern end of the wall. An elevation of the west wall, showing both the 1940's and 1962 wall is shown in Photograph 2.

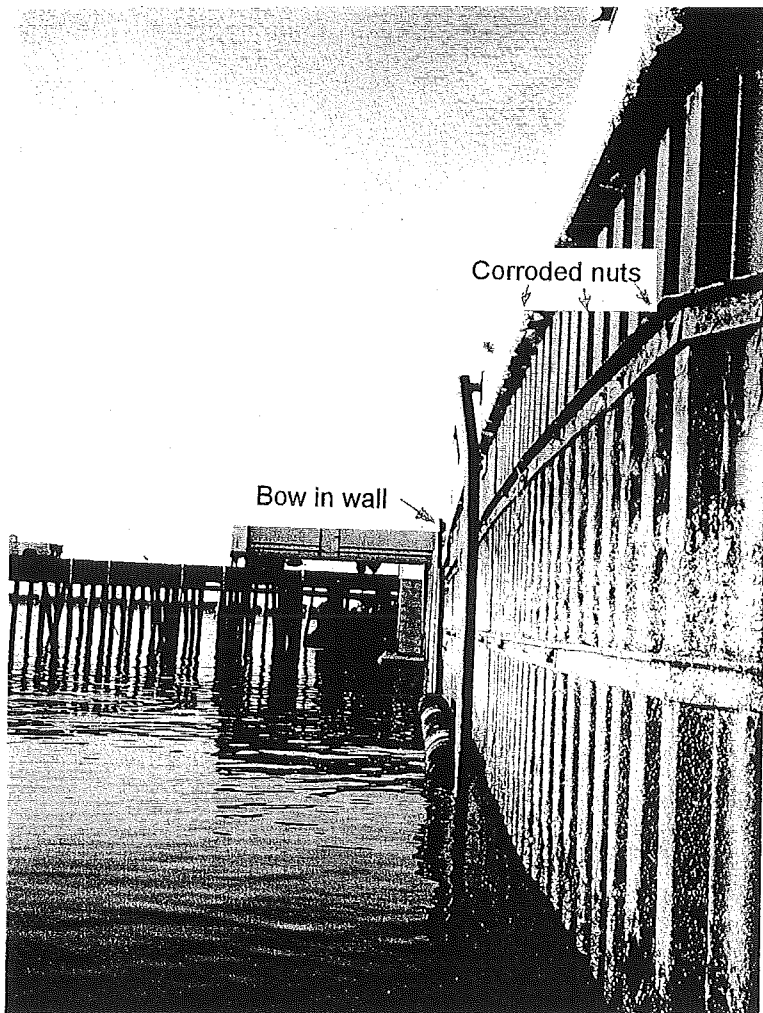
Photograph 3 -- West wall at south end, looking north

A bow was also noticed in the west wall as shown in Photographs 3 and 5. No detrimental effects from this bowing were observed. It may be that the bow has been there for many years, perhaps since the original construction.

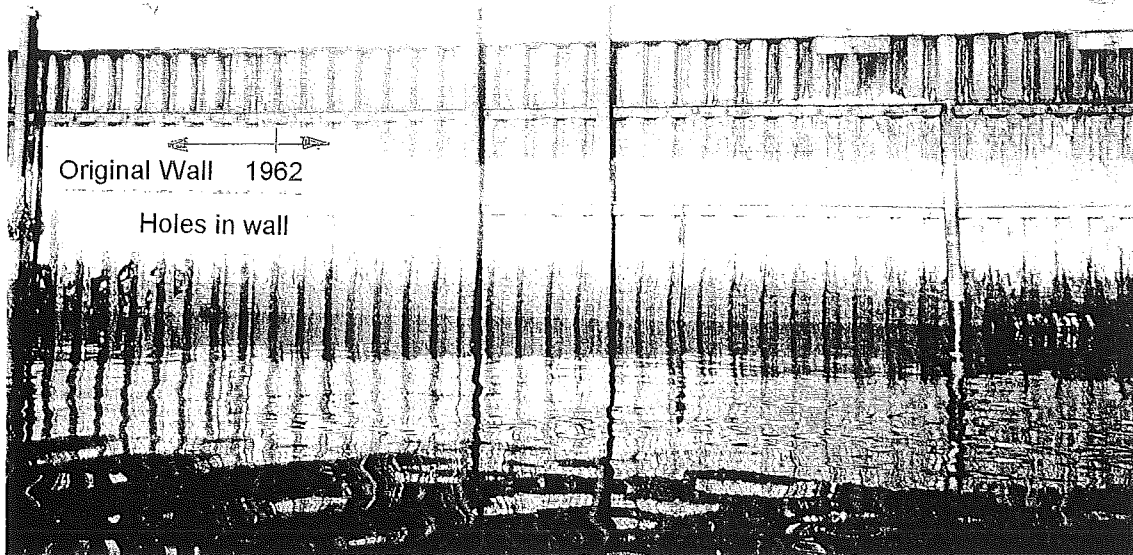
Photograph 8 -- West wall sta. 65 to 110

1. 1940's Wall (northern 100 ft. of the west wall, see Photographs 8 through 12.).
 - Completely rusted through at mean low water (MLW) for 30-40% of wall length (Figure 4).
 - Voids extend 3-5 ft. back into the wall backfill at MLW elevation.
 - Portion above mean sea level is intact, 40-60% of material remains.
 - Concrete cap has some spalled concrete exposing the rebar (Photograph 4).
2. 1962 Wall (southern 100 ft. of the west wall and south wall, see Photographs 6, 7, 8 and 13 through 16).
 - West Wall (see Photographs 6, 7, and 8) isolated holes are rusted through at low water. The openings equate to about 5-7% of the wall length.
 - Portion above mean sea level is intact, 50-70% of material remains.
 - South wall (see Photographs 13 through 16) two locations which have corroded through, one has water running out continuously at low tide, indicating extensive voids in backfill.

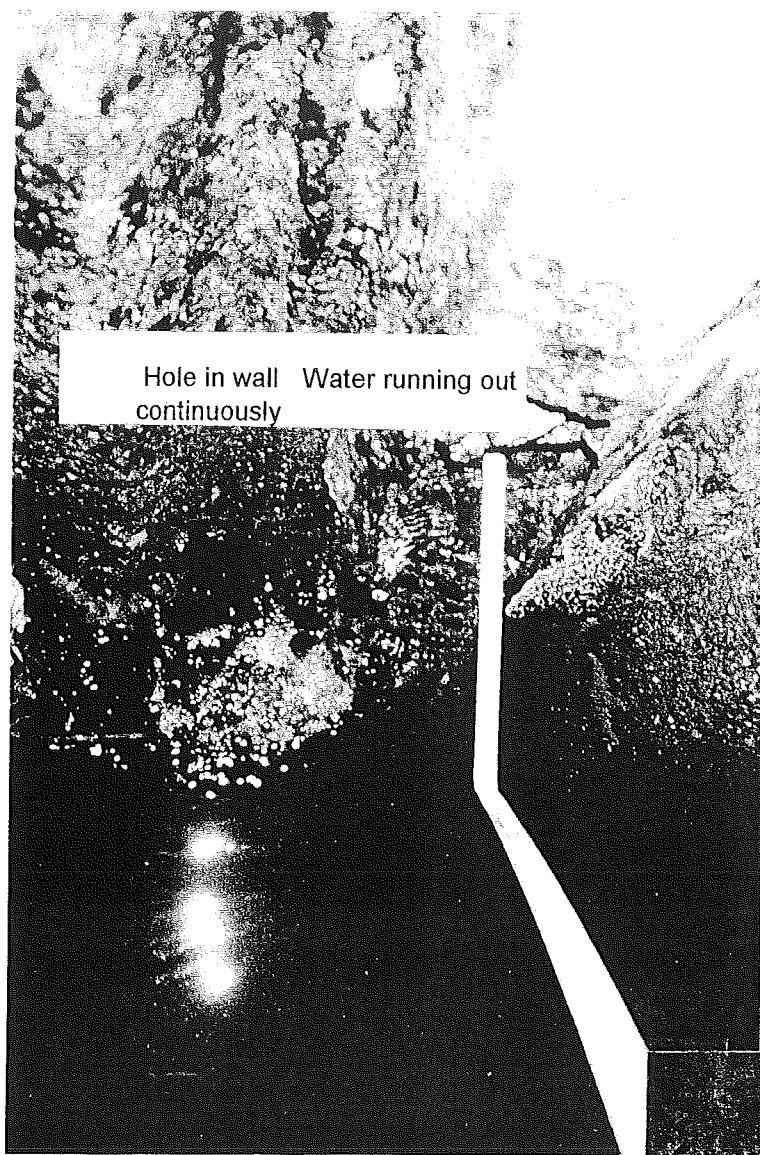
Photograph 16 -- South wall, sta 66

Hole in wall Water running out continuously

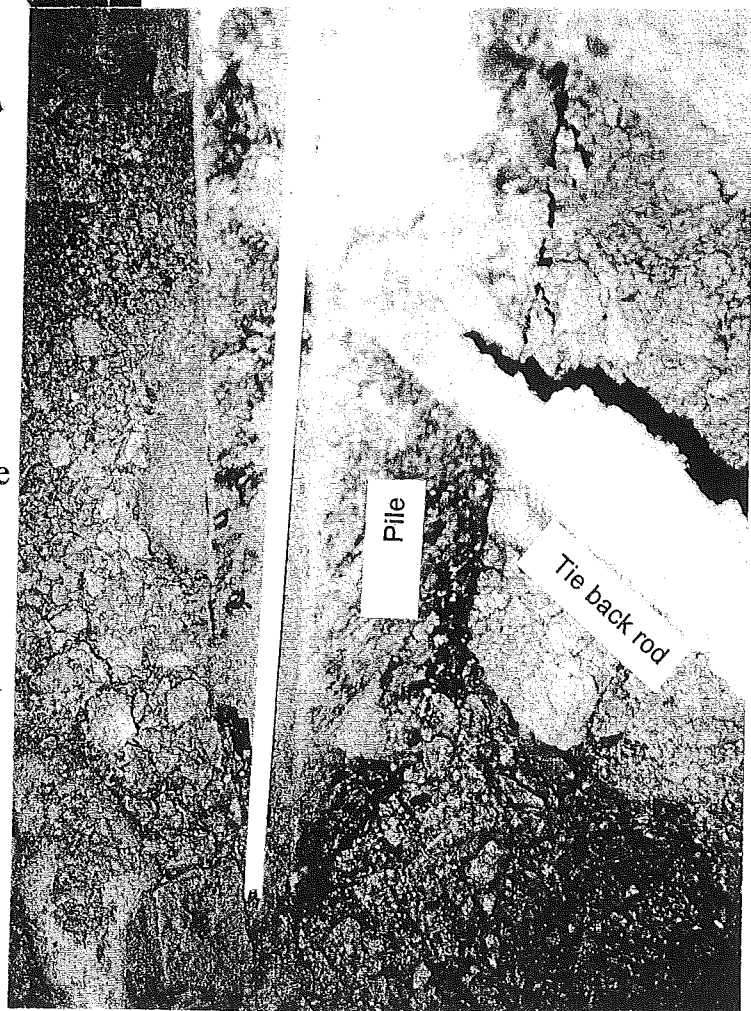
Photograph 17 -- Test Pit 1, tie back and pile

- Buried steel piles in good condition, 90% of material remains.
- Buried portion of tie rods in good condition, 90% of material remains.
- Walers are badly corroded, 30-50% of material remains.
- Nuts on end of tie rods are badly corroded, 20-35% of material remains.

Replace Corroded Tie-back Nuts. Replace the corroded nuts that are exposed on the ends of the tie rods, this would require cutting off approximately 2 feet from the ends of the tie rods and threading on a new rod, or welding a new rod onto the end of the existing rods.

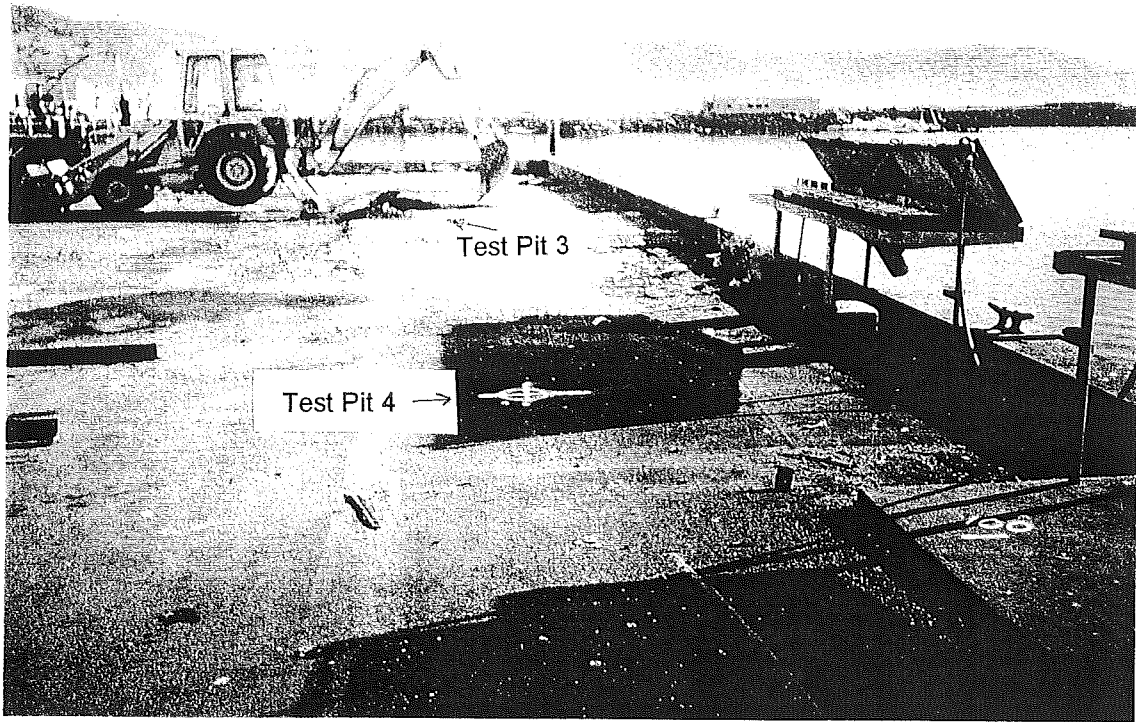
Photograph 18 -- Parking Lot, looking south at Test Pits 4 and 3

- Backfill at four test pit areas was sound - no voids were encountered.
- Backfill was sandy shale, predominantly granular and well drained.
