Subject: Sheet Pile Bulkhead Investigation—Report Submittal
M&N File No.4099

SHEET PILE BULKHEAD INVESTIGATION
Crescent City Harbor District
Crescent City, California

MOFFATT & NICHOL ENGINEERS
3000 Citrus Circle, Suite 230
Walnut Creek, California
M&N File No. 4099

Date Of Site Investigation:
11 December 1997

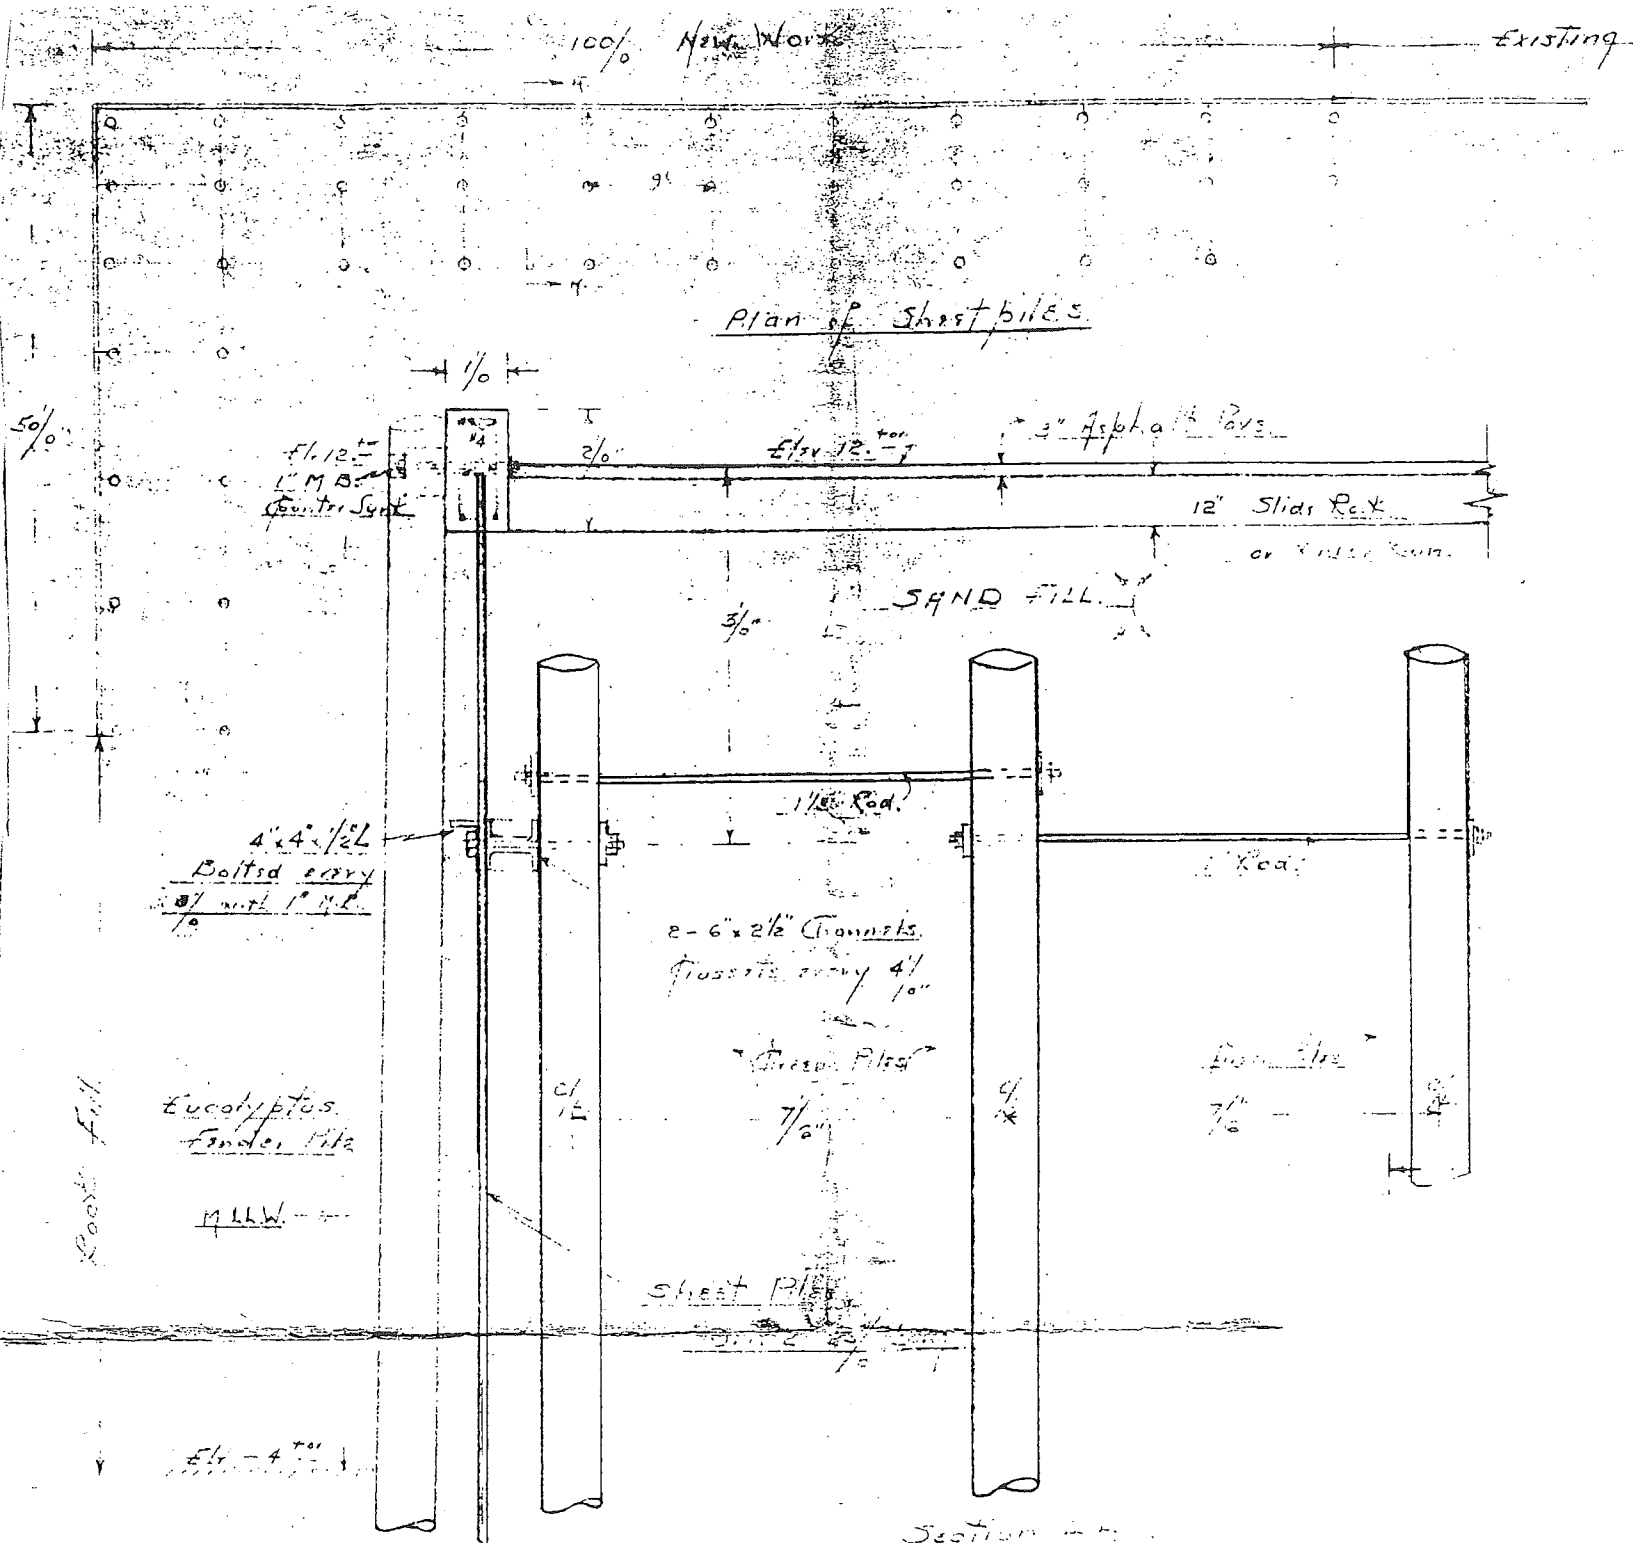
1940'S WALL -- SECTION AND PLAN

1. 1940's Wall (northern 100 ft. of the west wall, see Photographs 8 through 12.).
 - Completely rusted through at mean low water (MLW) for 30-40% of wall length (Figure 4).
 - Voids extend 3-5 ft. back into the wall backfill at MLW elevation.
 - Portion above mean sea level is intact, 40-60% of material remains.
 - Concrete cap has some spalled concrete exposing the rebar (Photograph 4).
2. 1962 Wall (southern 100 ft. of the west wall and south wall, see Photographs 6, 7, 8 and 13 through 16).
 - West Wall (see Photographs 6, 7, and 8) isolated holes are rusted through at low water. The openings equate to about 5-7% of the wall length.
 - Portion above mean sea level is intact, 50-70% of material remains.
 - South wall (see Photographs 13 through 16) two locations which have corroded through, one has water running out continuously at low tide, indicating extensive voids in backfill.
